# Operation UPSHOT-KNOTHOLE

March - June 1953

Project 3.6

TESTS ON THE LOADING AND RESPONSE OF  
RAILROAD EQUIPMENT

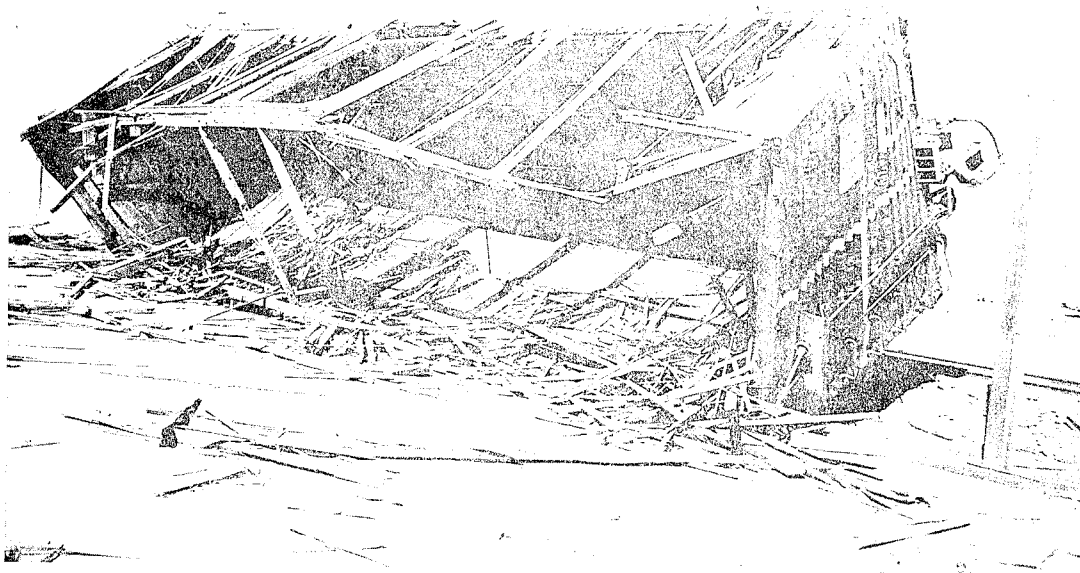
Fig. 4.10 Postshot, Damage to Wooden Boxcar, 3.6f

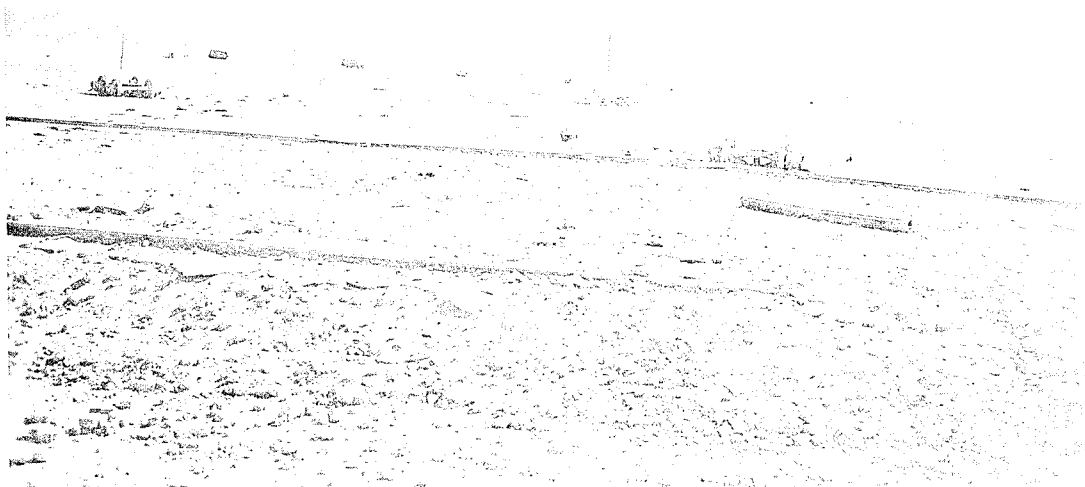
Fig. 4.13 Postshot, Site of Wooden Boxcar, 3.6i

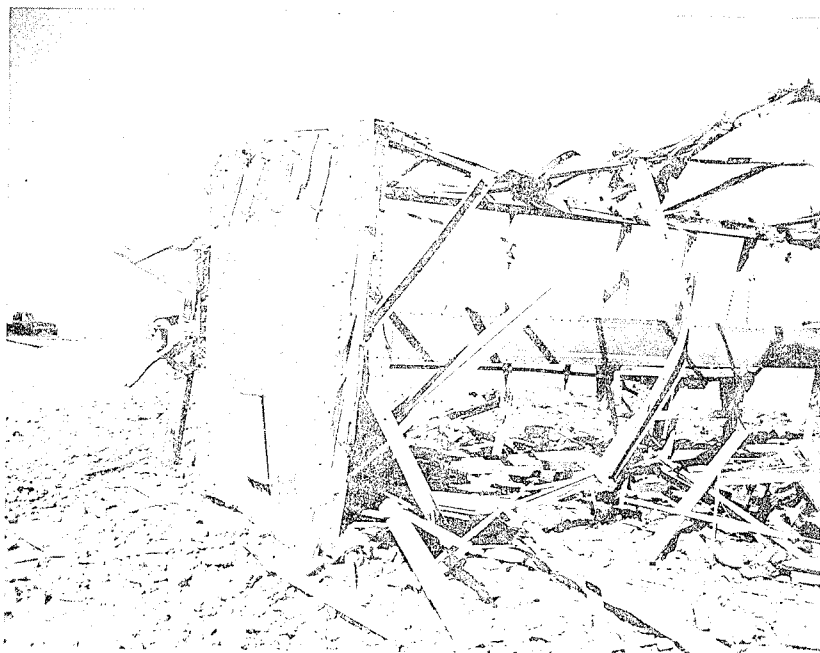
Fig. 4.14 Postshot, Damage to Loaded Wooden Boxcar, 3.6j (Note bowed ends and severe damage to box structure and frame)

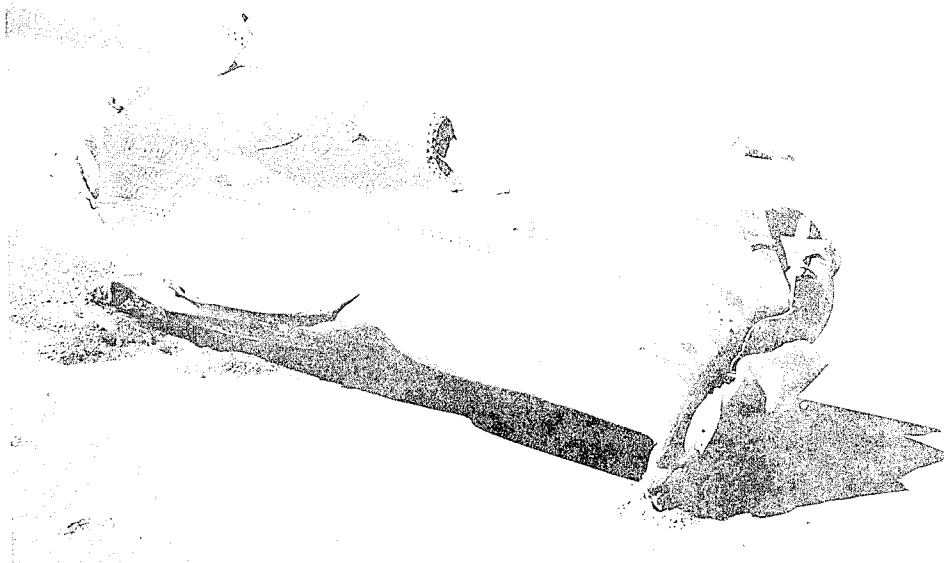
Fig. 4.20 Postshot, Damage to Shell of Riveted  
Tank Car, 3.6n
